**Lodz University of Technology, Faculty of Mechanical Engineering, Department of Vehicles and Fundamentals of Machine Design**

## CONTINUOUSLY VARIABLE TRANSMISSION LEAKAGE TEST RESULTS

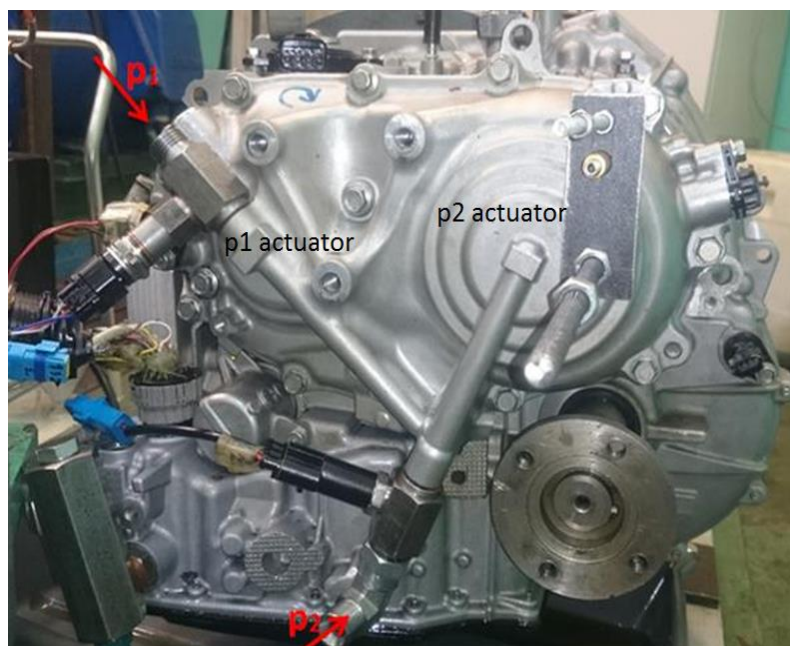
The external oil flow was delivered to both actuators by technological holes which were unplugged, as presented in Fig. 1 on the gearbox's side view.

Fig. 1. Picture of the tested gearbox  
Source: Author's

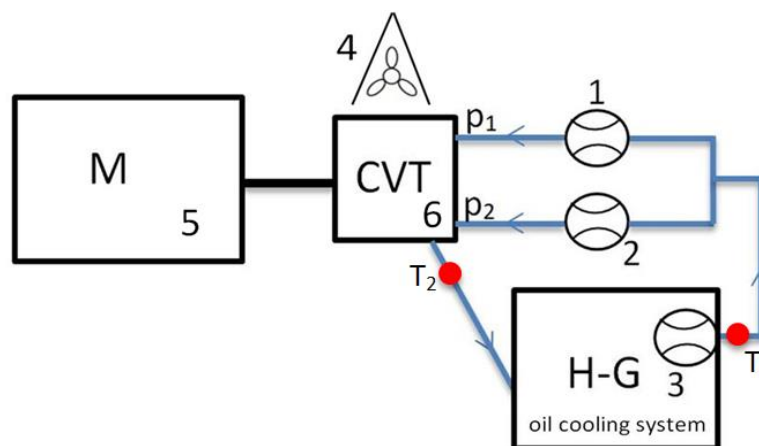
After this misfortune, another solution to supply the actuators was selected and is presented in the scheme of the test bench in Fig. 2. The CVT transmission (No. 6) is driven by an electric motor (No. 5) characterized by its maximum rotational speed of 3000[rpm]. The needed pressure value is supplied from the hydraulic group (No. 3) (H-G). Hydraulic group contains an oil filter with 3 micron solid particulate filtration, a flow-meter and regulation of temperature of output oil. An oil filter in original gearbox's hydraulic circuit is employed as well to keep oil uncontaminated.

The oil is delivered to both pulley's actuators. The oil which enters each chamber is measured by flow-meters No. 1 and No. 2. One of them, has a small range of 1,6[l/min] with measurement tolerance 1[%] and values from this flow-meter were taken for all further analyzes because the expected maximal value of leakage was about 1[l/min]. After tests of the P1 pulley, the position of this flow-meter was changed from "1" to "2" in order to precisely measure the value of leakages on the second actuator. Oil which passed through the sealings dripped to the oil sump and when the amount exceeded a specified level was directed to the hydraulic group - Fig. 2.

Two oil temperature sensors were applied. The  $T_1$  sensor (Fig. 2) measures the CVT's input oil temperature which delivers the H-G. This temperature is controlled by the cooling system of H-G and was always kept constant during particular test series. Because this is supply line for CVT, this value of temperature was selected as a reference during research. The  $T_2$  sensor was employed to check the temperature of oil which quit the CVT gearbox. To achieve the best uniformity of temperature in the gearbox and most accurate results, both temperatures had to be similar at the beginning of the test. The fan (No. 4) was used to intensify the dissipation of heat from the gearbox during tests at high rotational speed. Temperature phenomena will be described further.

Fig. 2. Scheme of the test bench  
Source: Author's

The test stand correspond to real conditions in a car because electric motor (No. 5) substitutes the engine. Additional fan (No. 4) simulates the air flow which occurs during driving and cools the gearbox. H-G (No. 3) replaces the original oil sump with integrated radiator.

flow meters was employed in order to have an additional control of flows and make measurements more reliable. It was interesting how big was the difference between the sum of the value from flow-meter's "1" and "2" in comparison with the value indicated on flow-meter "3"- see Fig. 2. It was noticed that for most measurement points this difference is smaller than 0,05[l/min]. This proved the reliability of the flow-meter's precision.

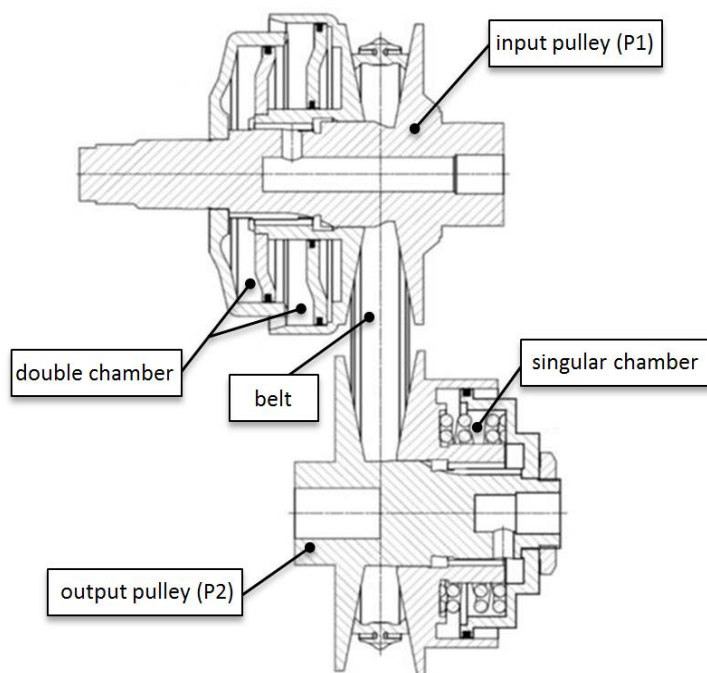
It should be underlined, that the P1 pulley has a doubled actuator chamber (with a total area of 175[cm<sup>2</sup>]) while the P2 actuator chamber is single and has 82[cm<sup>2</sup>] area, as shown in Fig. 3. P<sub>2</sub> pressure is highest in the Jatco CVT 7 and it was necessary to double the P1 actuator to achieve greater axial force to the P1 actuator to enable the ratio change.

Fig. 3. Cross section of CVT

Fig. 5 shows test results for the P2 actuator, 0[rpm] and various values of oil temperature. The maximal value for 80[°C] is close to 1,2[l/min] which is noticeably more than for the P1 actuator. When compared to P1 results it can be observed different shape and there is no leakage fall when pressure is increased. Different properties can be explained by the distinct design of actuators presented in Fig. 3.

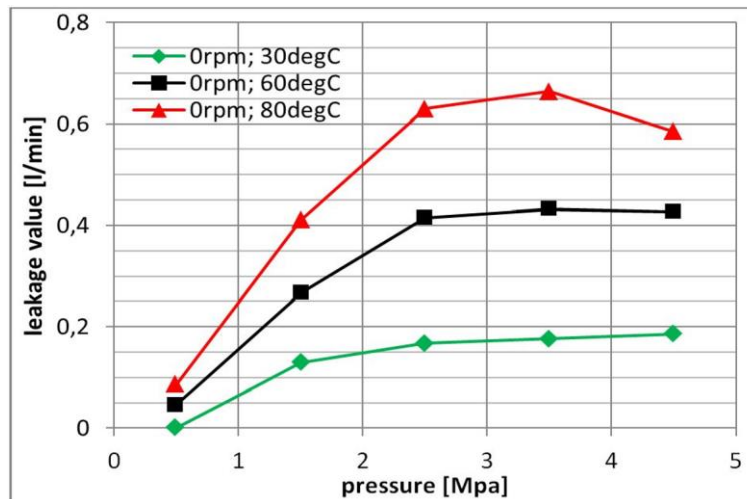
Fig. 4 shows the test results for the P1 actuator and different values of oil temperature. The maximal value of leakage (0,65[l/min]) can be observed for the highest oil temperature (80[°C]) and pressure 3,5 [MPa]. The shape of the achieved curves is thought provoking. The higher the pressure, the lower the increase of leakage can be observed. This was particularly for the highest temperature range when leakages dropped a little at top pressure.

There could be two explanations of this phenomenon. First concerns the oil temperature - before the test the gearbox was warmed to the required temperature by turning the gearbox shafts. When the test started (for 0[rpm]) the oil inside CVT started to cool which caused a drop of leakage, regardless of the pressure increase. Nevertheless, the impact of this process should be slight because the whole test lasts only a few minutes. The second explanation relates to the sealings and their features. It is possible that due to higher pressure the sealing tightens which contributes to lower leakages. Most likely the answer is a combination of both mentioned theories.

Fig. 4. Test results for P1 actuator, 0[rpm] and different values of oil temperature  
Source: Author's

According to the test results, there are two main factors which strongly influence leakages: pressure and temperature. It was expected that the higher the pressure, the higher the leakages. Generally, this rule is proved by test results. However, there are a few points of these principles which seem untrue - Fig. 4. This is most likely caused by the second main factor: temperature. Tests from Fig. 4 were performed at high temperature when the motion was stopped. After a few measurement points, the gearbox began to become cold, which probably disturbed the measurement. The opposite situation is visible at high rotational speed. The curve for 3000[rpm] has the highest slope because the transmission becomes hot very fast. This is also probably the reason the values of leakages are more or less the same at the beginning point of the test (0,5[MPa]) for all rotational speeds. The curve at 500[rpm] is sloped weakly, and stronger at 1000[rpm] and 3000[rpm] mostly. If the influence of centrifugal force would be significant, the layout of curves should look different: the difference between all curves (for different rpm) should be noticeable from the beginning and remain more or less the same, to the end of the curves (4,5[MPa]). That's why the influence of centrifugal force could be omitted here. Summarizing, the layout of temperatures inside the gearbox is hard to be determined precisely. It changes depending on current rotational speed. Changes of temperature inside the pulleys chamber result in changes of leakages.

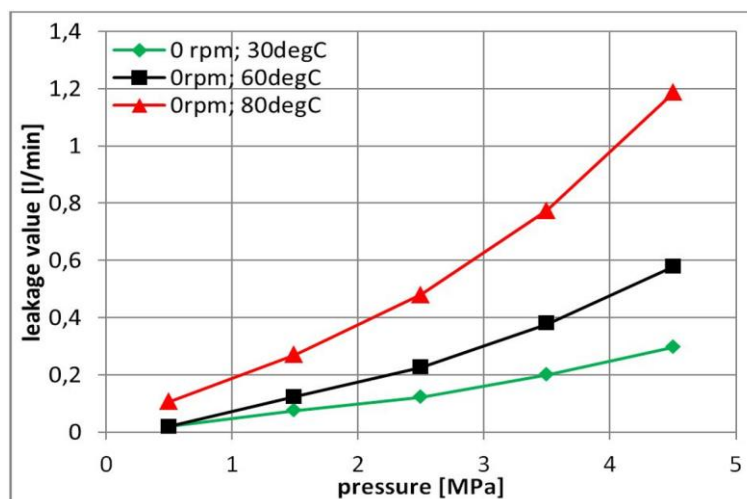
Fig. 5. Test results for P2 actuator, 0[rpm] and different values of oil temperature  
Source: Author's

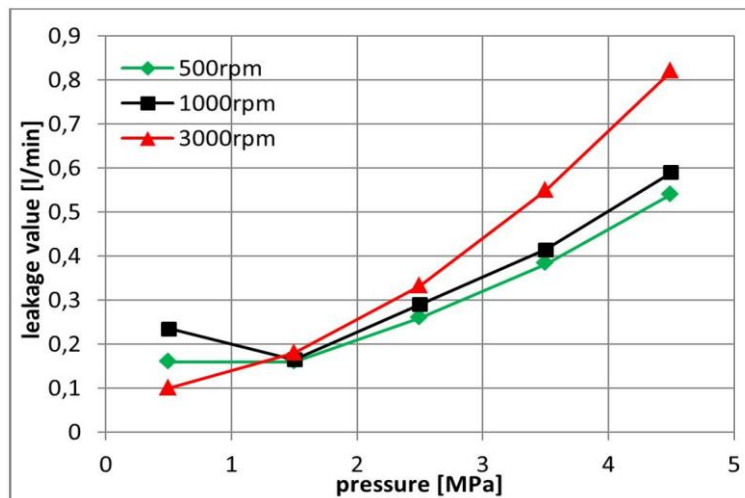
In Fig. 6 the leakage values are presented for the P1 actuator at 80[°C], at various rotational speeds. Based on the results from the mentioned graph, a general tendency can be observed for leakages for all values of rotational speed increase together with increased pressure. The next remark concerns the fact that the curves of higher values of rotational speed are steeper. A probable explanation is connected with temperature phenomena. Analogously, like the small drop of leakages from Fig. 4 was explained by the lowering of oil temperature at the contact area of belt and pulleys, this time higher rotational speed causes more severe warming of oil inside the gearbox (mainly because of friction). As shown in Fig. 6, leakages increase more rapidly during the test. The highest value of leakage slightly exceeds 0,8[l/min]. It was possible to control the  $T_1$

temperature (the input one) but not the  $T_2$  temperature (the output one) because it was not feasible to apply cooling inside rotating CVT (and its actuators). The fan (Fig. 2) was used to reduce this phenomenon.

Fig. 6. Test results for P1 actuator, temperature of oil 80[°C] and different rotational speed values  
Source: Author's

Fig. 7 depicts test results for P2 actuator at temperature 80[°C] and various values of rotational speed. Results are similar to those from Fig. 6. All previously mentioned relationships are also visible and true. The most significant difference concerns the value of leakages – such as for 0[rpm], leakages for P2 actuators are greater and for results from Fig. 7 achieve nearly 1,2[l/min] for 3000[rpm] and 4,5[MPa].

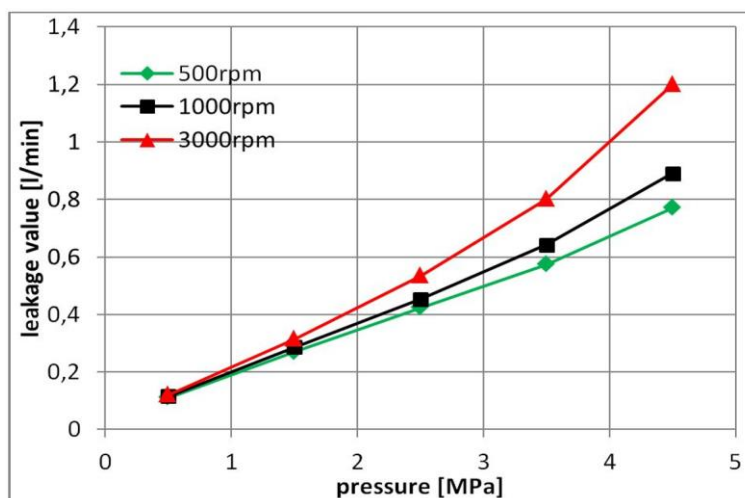
Fig. 7. Test results for P2 actuator, temperature of oil 80[°C] and different rotational speed values  
Source: Author's
